Section 4-2

Replace Power Steering Cooler Hoses

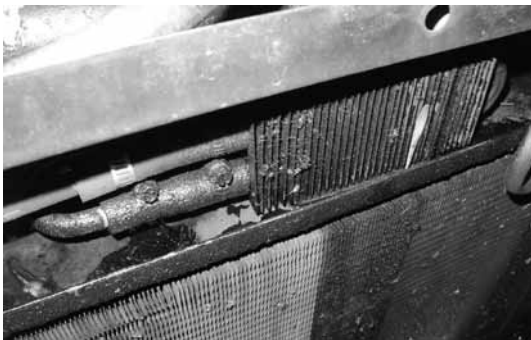
This is an easy fix for a common issue: red automatic transmission fluid dripping from underneath the radiator. You might think it to be the transmission cooler at first, but more often than not, it's the power steering cooler hoses.

Figure 4-2-1 – Radiator support drowning in fluid.

As you can see in fig. 4-2-1, the radiator support underneath the power steering cooler can completely fill with fluid. Access to the unit is improved if the deflector panel

The materials needed to fix the leaks are limited to one foot of 3/8-inch I.D. power steering return line and four hose clamps. Name brand hose stock such as Goodyear and stainless hose clamps are available at

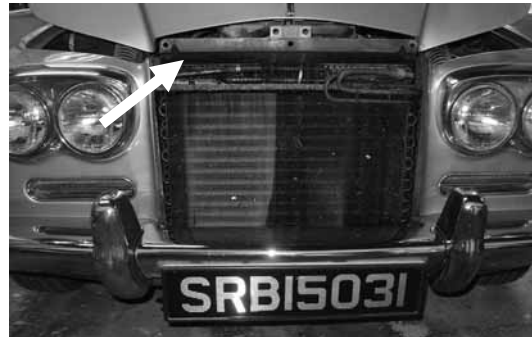
Figure 4-2-2 – Access improves with the deflector panel out.

on top of the radiator is removed. (See fig. 4-2-2.) The remainder of the procedure is simple. Remove the bolts securing the cooler, loosen the hose clamps and pull off the cooler and hose pieces being careful not to spill ATF all over the place.

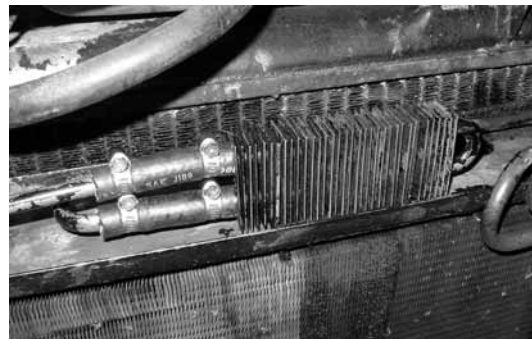
Figure 4-2-3 – New hoses and hose clamps in place.

After cleaning the cooler and surrounding area, cut two new hoses to match the old ones. Reassemble the cooler using the new hoses and hose clamps. Position the hose clamp screw heads facing

forward to allow future tightening without the need for grille removal (See fig. 4-2-3.)
